(P) Report on MISSOURI RIVER
SIOUX CITY, IOWA TO RULO, NEBRASKA

(6) POTAMOLOGY INVESTIGATION

A STUDY OF THE SHIFT IN THE
STAGE-DISCHARGE RELATIONSHIP OF
THE MISSOURI RIVER AT SIOUX CITY, IOWA

PREPARED BY
WATER AND ENVIRONMENT CONSULTANTS, INC., Fort Collins
UNDER
CONTRACT NO. DACW45-75-D-0003

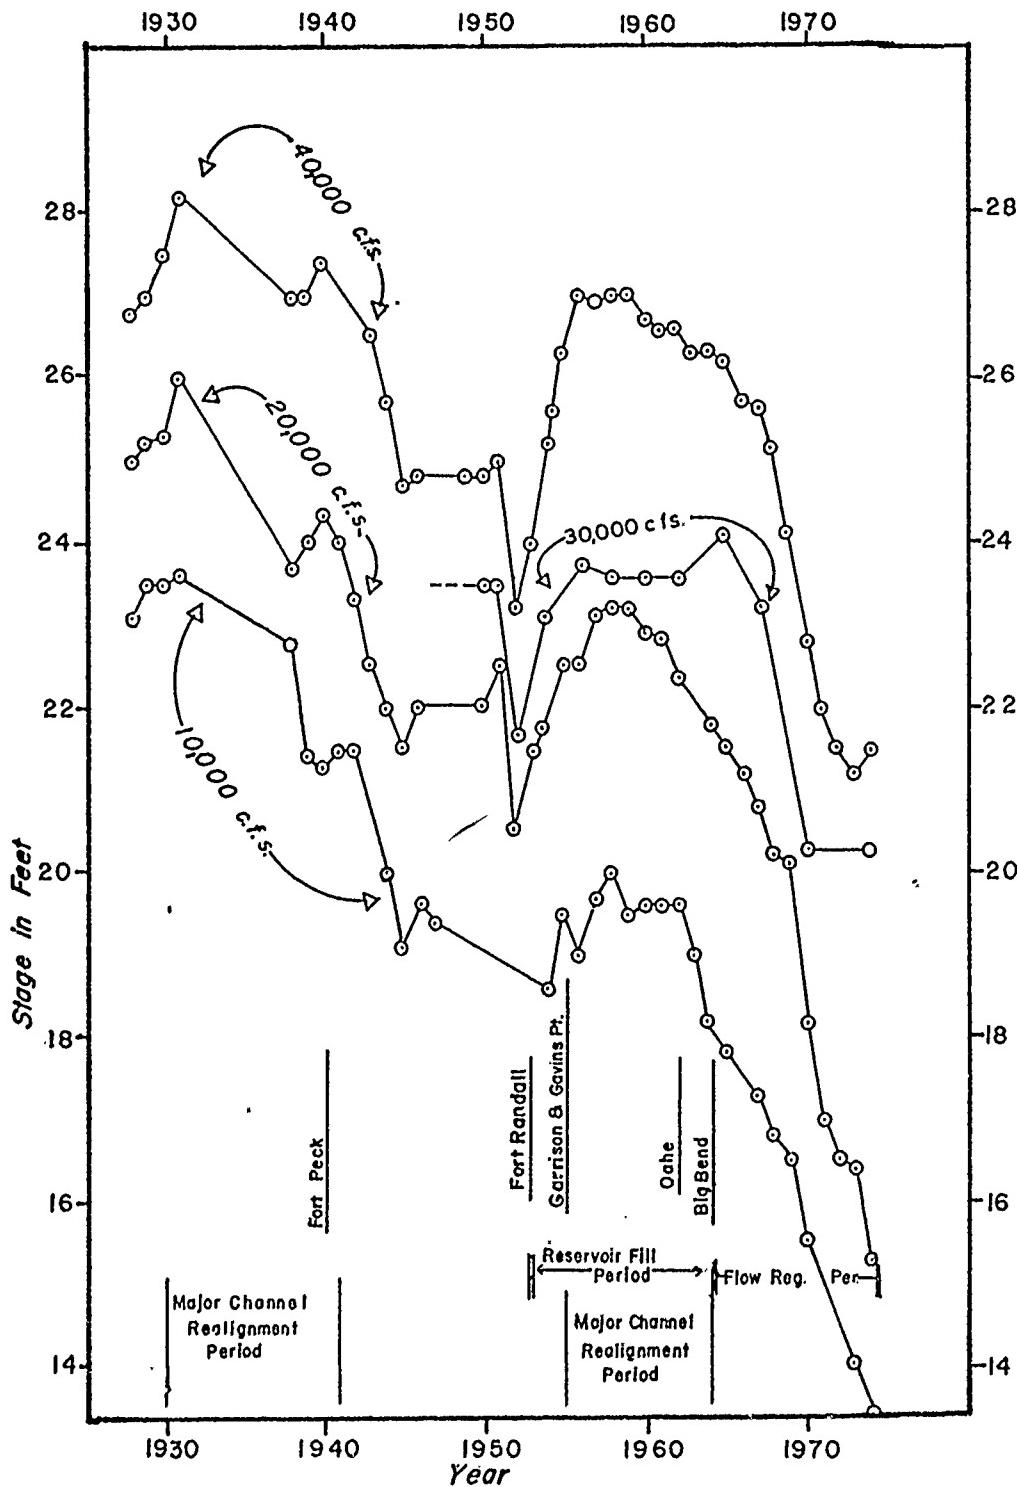
Figure 1. STAGES FOR CONSTANT DISCHARGES,
MISSOURI RIVER AT SIOUX CITY, IOWA

The change in the stage-discharge relationship at Sioux City is illustrated in Figure 1, which shows the resulting stage, as measured from an MSL datum, for given discharges over the last 45 years. The large shift in stage which has occurred since approximately 1960, and the increased rate of change beginning in 1967 as seen in the Figure, are the focus of this study.

The history of the stage-discharge relationship as depicted in Figure 1 provides some insight into the factors which have influenced the relationship. One noticeable fact is that a similar drop in stage occurred from 1930 to 1944. This time frame coincides with a major channel realignment period as does the stage change beginning in 1958. From 1945 to 1952 the stage-discharge relationship experienced a stable period during which no major construction occurred. Following 1952 until around 1960, the stage values increased. This rising follows the construction of Randall and Gavins Point Dams. The 1952-1960 period had relatively low mean yearly discharges at Sioux City, Iowa, as seen in Table 6. The low discharges, coupled with degradation below Gavins Point Dam and subsequent deposition farther downstream, could

account for the rising of the stages at Sioux City from 1952-1960 shown in Figure 1. The period from 1960 produced a dropping stage for a constant discharge with an increase in the rate of drop beginning around 1969. The drop for this period occurred in the presence of major channel realignment and increased mean yearly flows shown in Tables 6-8.

The shift in the stage-discharge relationship at Sioux City, Iowa, has resulted in a 5-8 foot lowering in stage for a constant discharge in the period from 1960 to the present. Figure 1 shows that the rate of shift increased around 1968. The reasons for the shift are found in the historical records of the Missouri River from 1950 to the present.

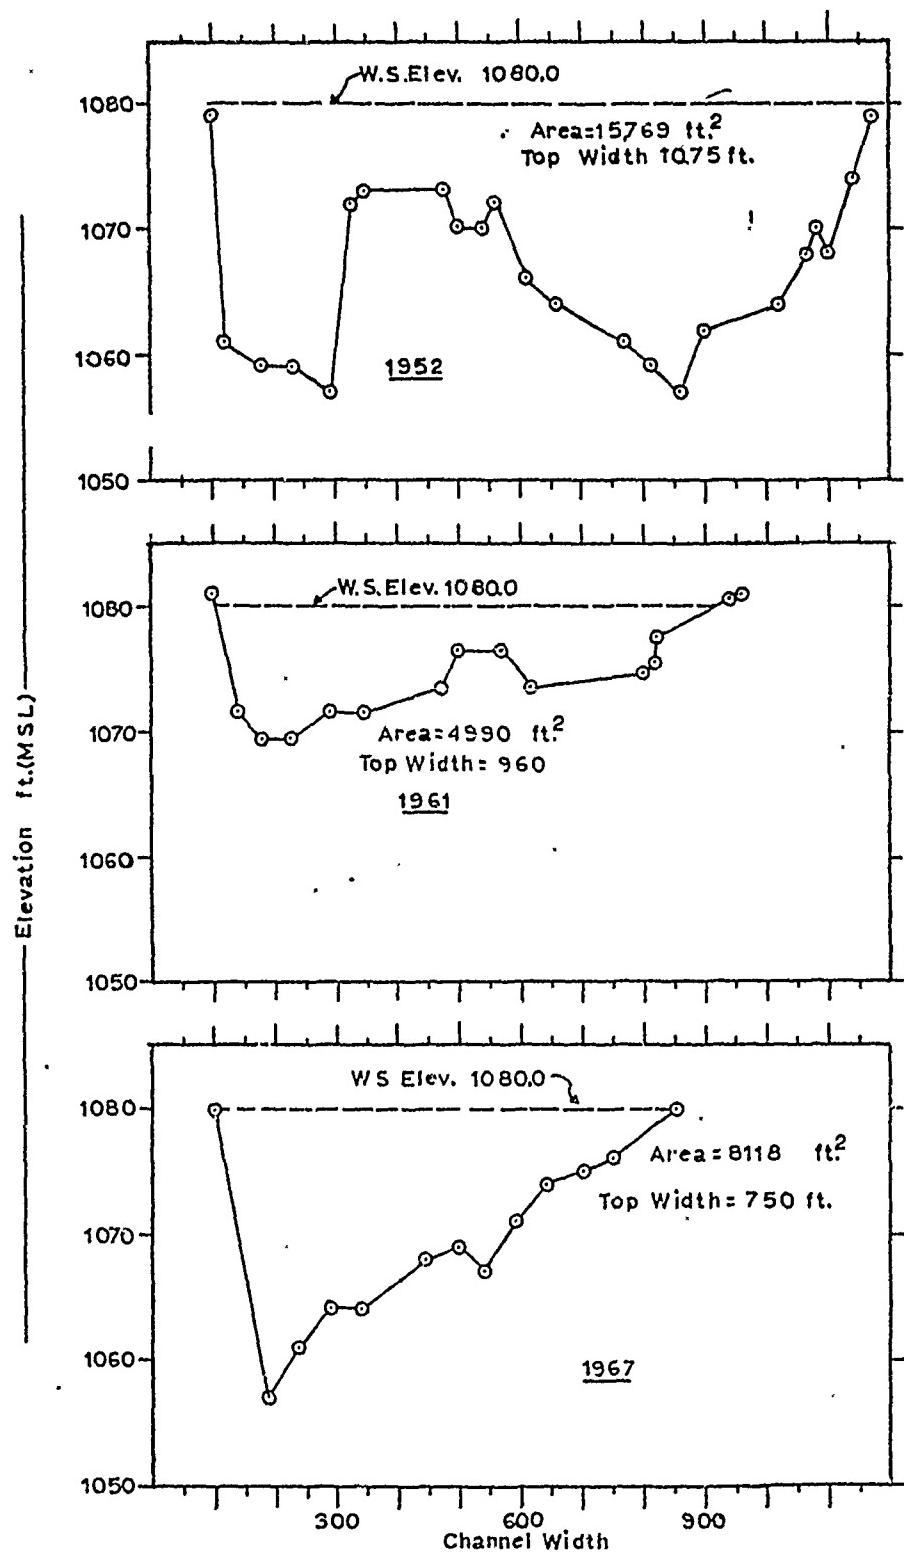
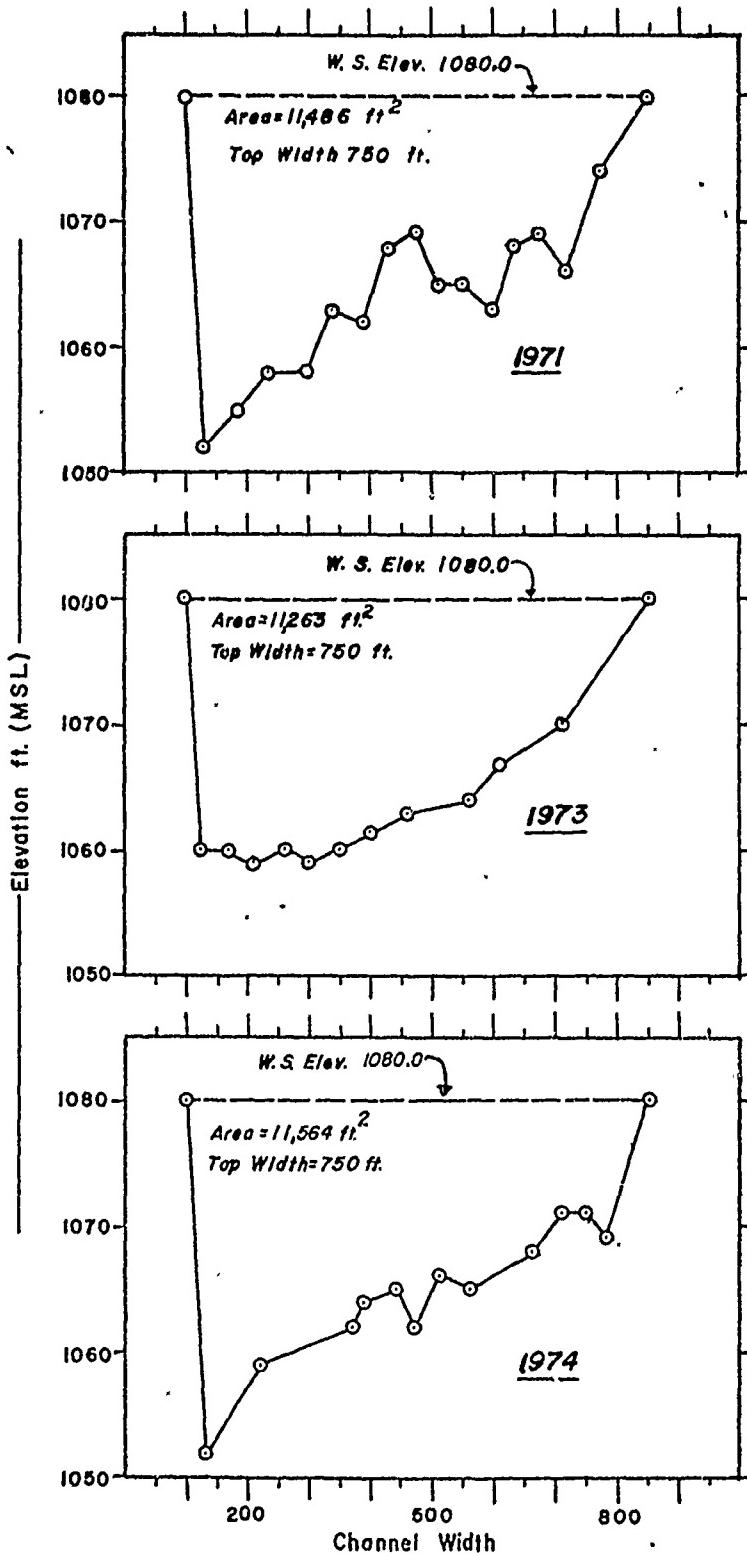
FIGURE 3. CHANNEL CROSS SECTION HISTORY
AT RIVER MILE 731.7

The channel cross section history of the Missouri River near Sioux City, Iowa is available at three cross sections. Figures 3 through 5 show the channel cross section for the years 1952, 1961, 1967, 1971, 1973, and 1974 at River Miles 731.7, 731.49, and 727.9 (excluding 1973 in Figure 5). Figure 6 is a location map for these points. Each cross section is plotted in reference to a constant water surface elevation to observe degradation tendencies at Sioux City over the years. The cross sections show that in the years between 1961 and 1967 the channel top width was narrowed approximately 210 feet at mile 731.7, 330 feet at mile 731.49, and 457 feet at mile 727.9 (1960 mileage). These figures represent an average reduction in top width of 32 percent. The narrowing was actually done in the period 1963-1965 by lengthening the dike field and inserting additional dikes between the existing ones.

Another change in the channel was experienced in the period from 1952-1961. Figures 3 through 5 show that a general rise in bed elevation occurred during the years just after construction of Gavins Point dam. The cross sectional area was also greatly reduced in the period from 1952-1961. Figure 7 shows the values of cross-sectional area for the cross-sections previously mentioned.

channel near Sioux City. After the flood, and up until the late 1960's, the channel bed rose in elevation as seen in Figures 3 through 5. Degradation below Gavins Point Dam since 1955 and subsequent deposition in reaches downstream built up the bed elevation during this period. Since 1967, the channel cross-section has increased in area and assumed more the appearance of a rectangular channel than that of a typical bend with a point bar. The area increase and change of channel shape are a result of high flows and relatively small sediment inflows, as will be discussed in following sections.

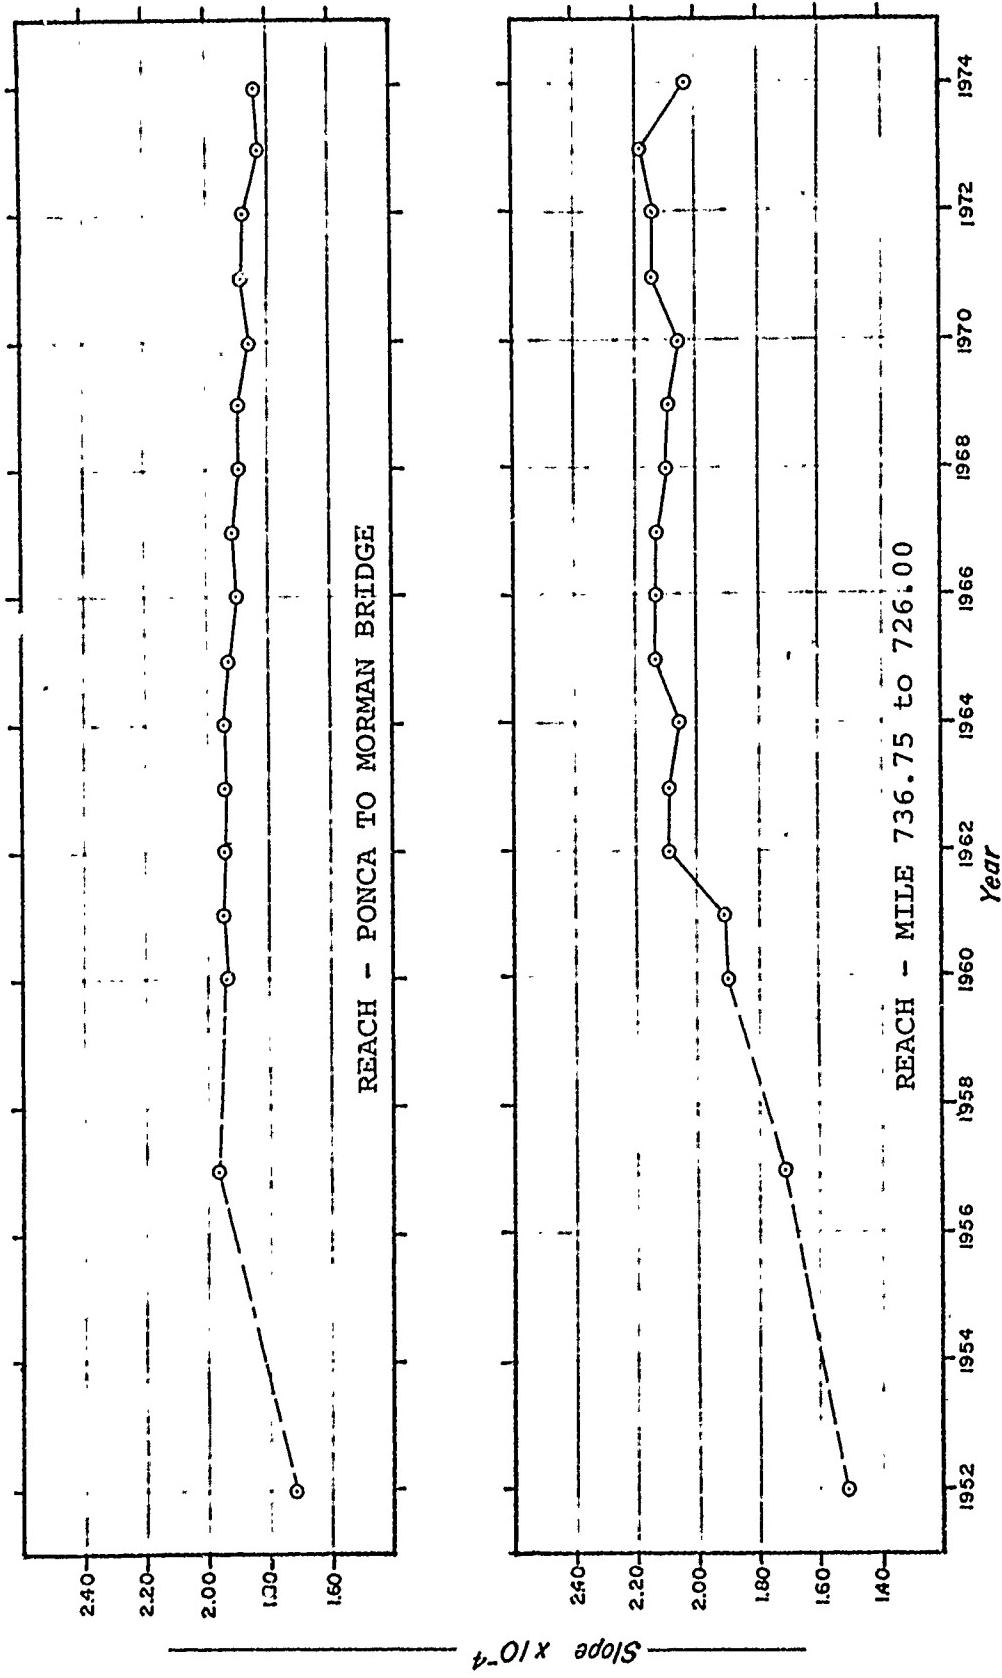
FIGURE 8. MISSOURI RIVER CHANNEL SLOPE,
DISCHARGE OF 30,000 cfs

The slope of the water surface of the Missouri River was recorded at various time since 1952 for a condition of constant discharge for the reach between Ponca, Nebraska, to Omaha, Nebraska. Figure 8 shows the change in water surface slope both locally at Sioux City, Iowa, and over the entire reach between river miles 753.7 and 626.5 for the period being studied. The slope was greatly increased between 1952 and 1958 both over the long reach and locally. Since 1958 the reach from Ponca to Omaha has reduced the slope, which would be expected because of the scouring in the upstream areas of the reach. Locally, the reach continued to increase its slope until 1974. This does not imply that the local reach is aggrading, but that the lower end of the reach has degraded more than the upper end over the years.
